REQUEST FOR ACTION

To Protect the Middle Fork of the Vermilion, a National Scenic River

Prepared for the Illinois Department of Natural Resources

by Eco-Justice Collaborative
919 West University Avenue
Champaign, IL 61821
773.556.3417 / 3418

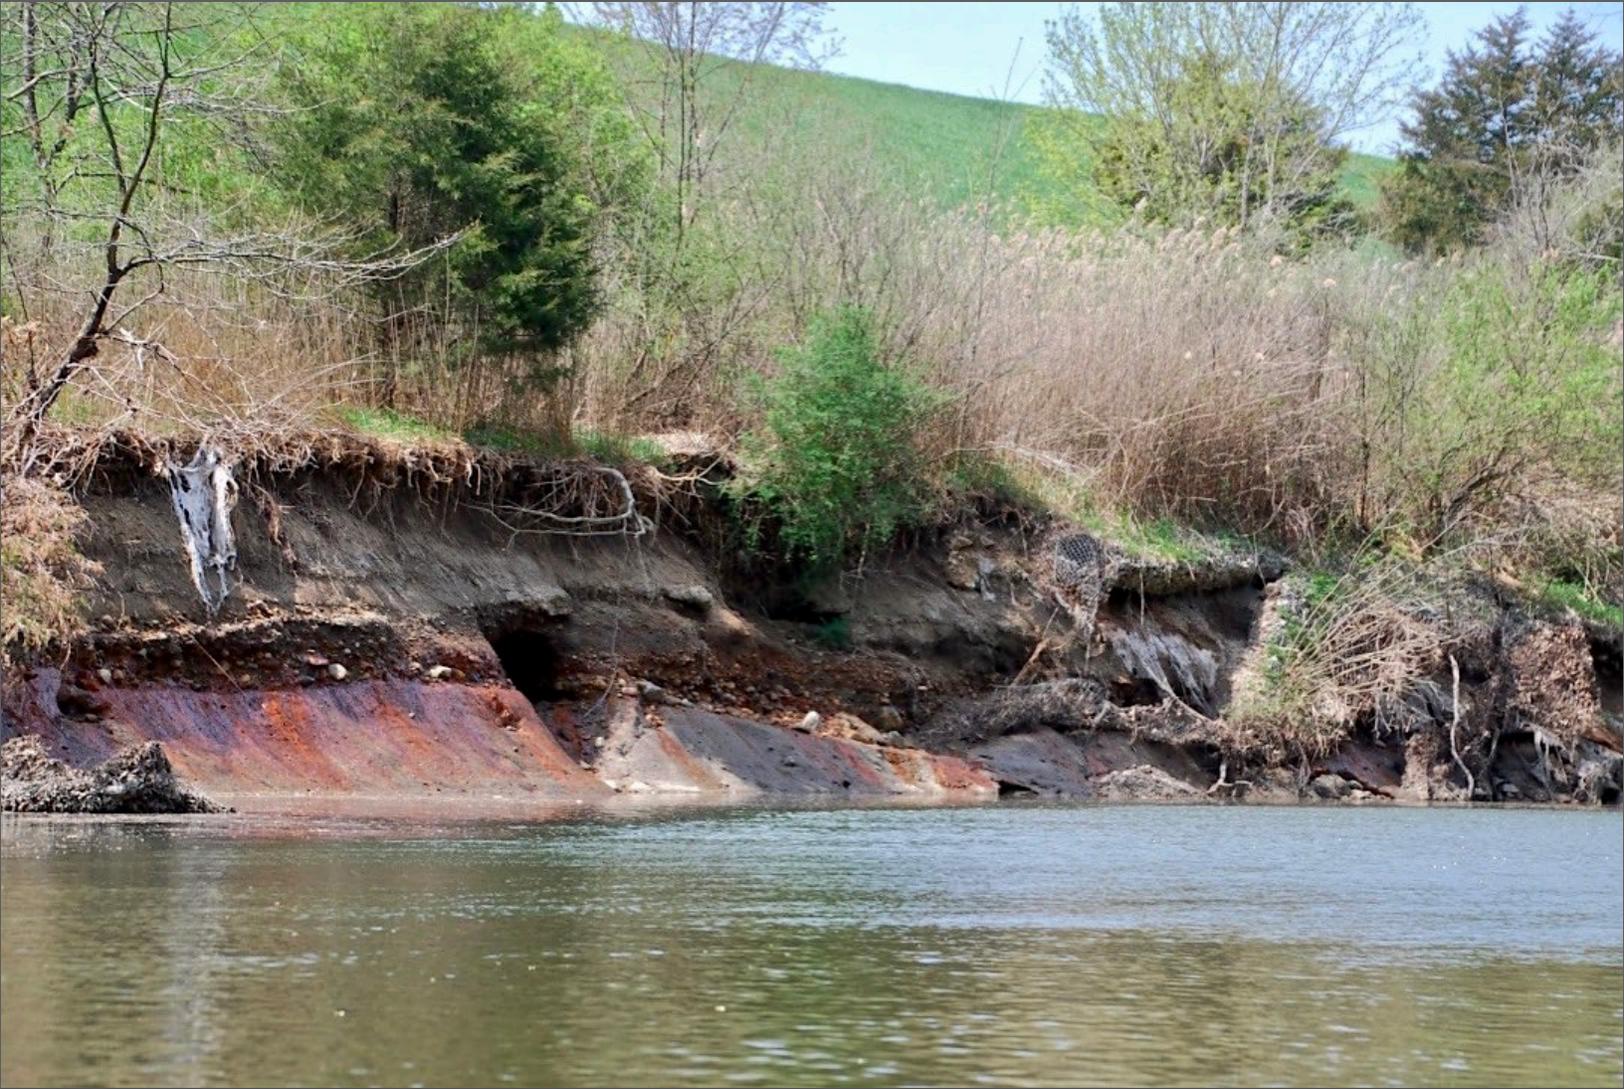
Gabions installed to protect riverbanks from the meandering river have been ripped off banks and deposited in the river or swept downstream. Unmitigated erosion undercuts riverbanks. Eco-Justice Collaborative. May 2, 2018

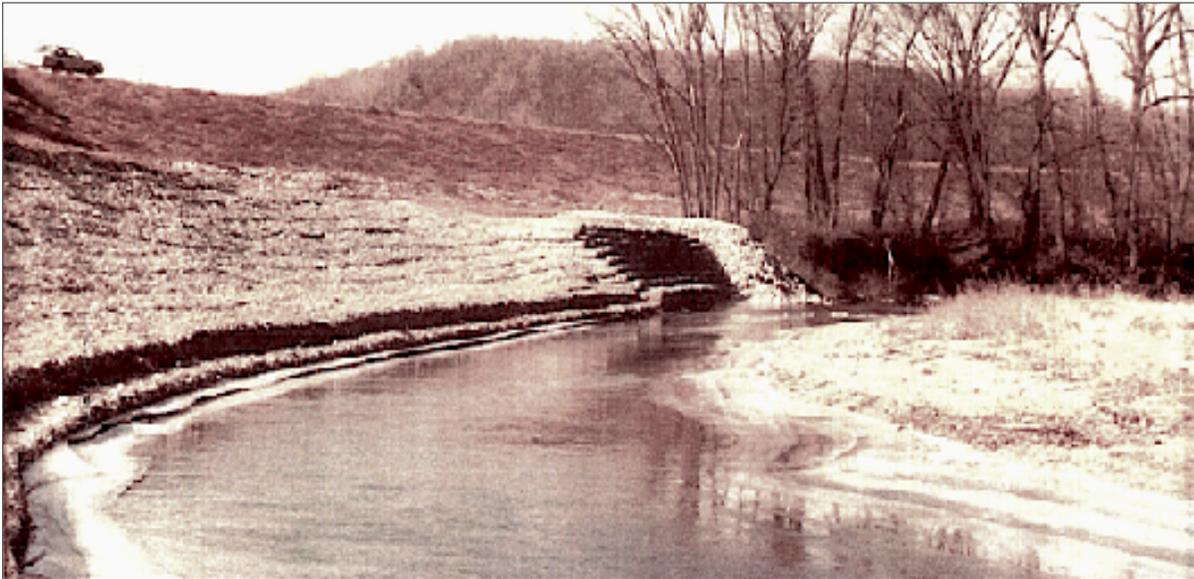
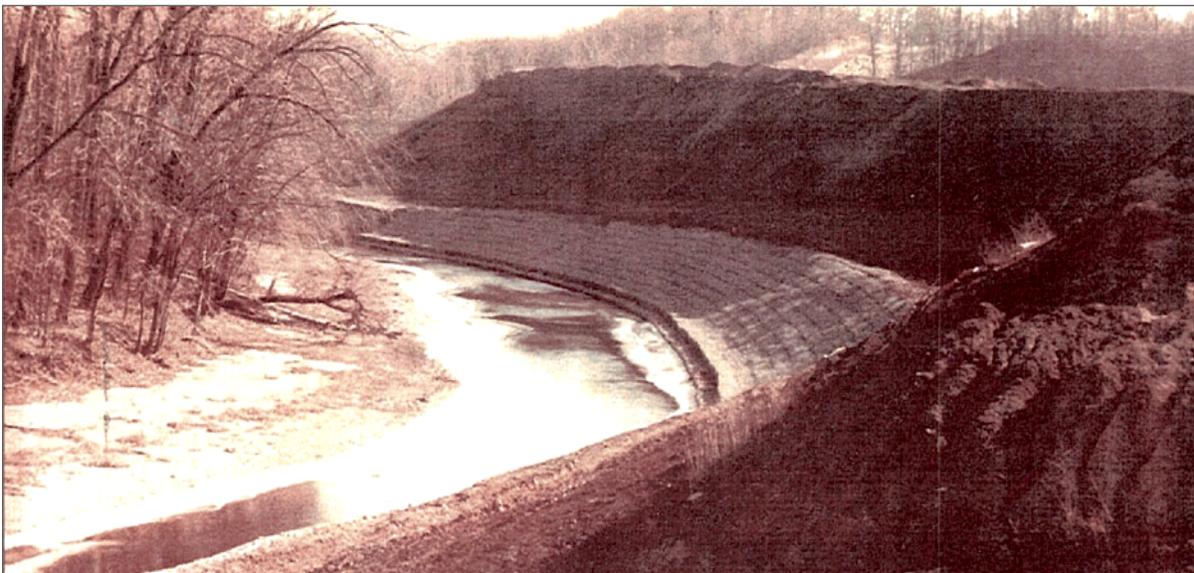
Photos of 1981 stabilization project presumed to be taken by Illinois Power. Source: FOIA Request, IDNR.

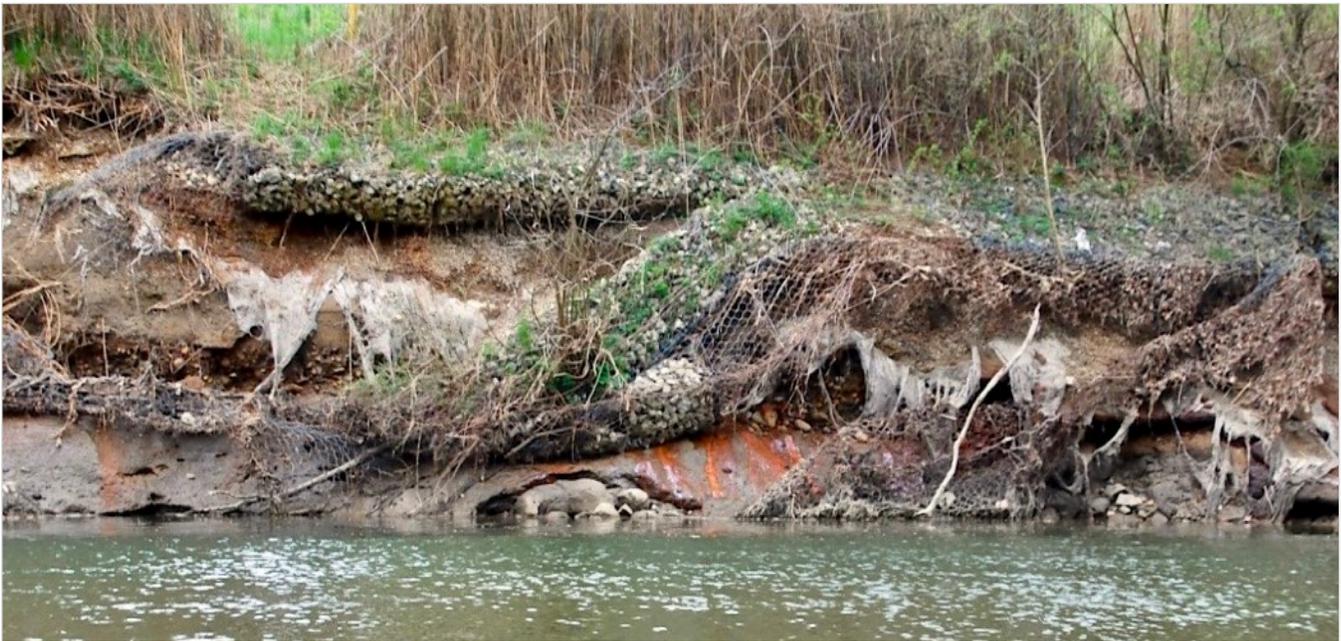
Deteriorating gabions installed along riverbank next to the Old East Ash Pit in 1981. Eco-Justice Collaborative. May 2, 2018.

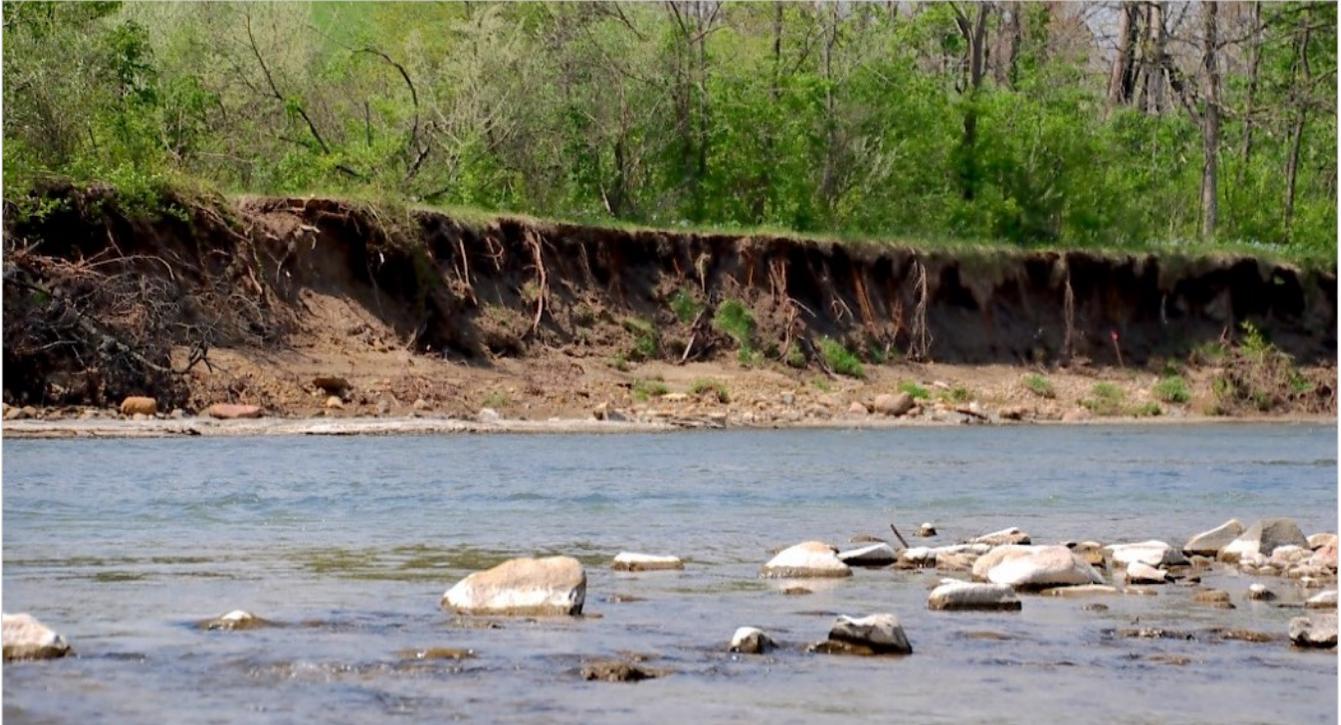
At one location, erosion from the Middle Fork River left just 10 feet of separation between the top of bank and toe of the New East Ash Pit dam.. Eco-Justice Collaborative. April 24, 2016.

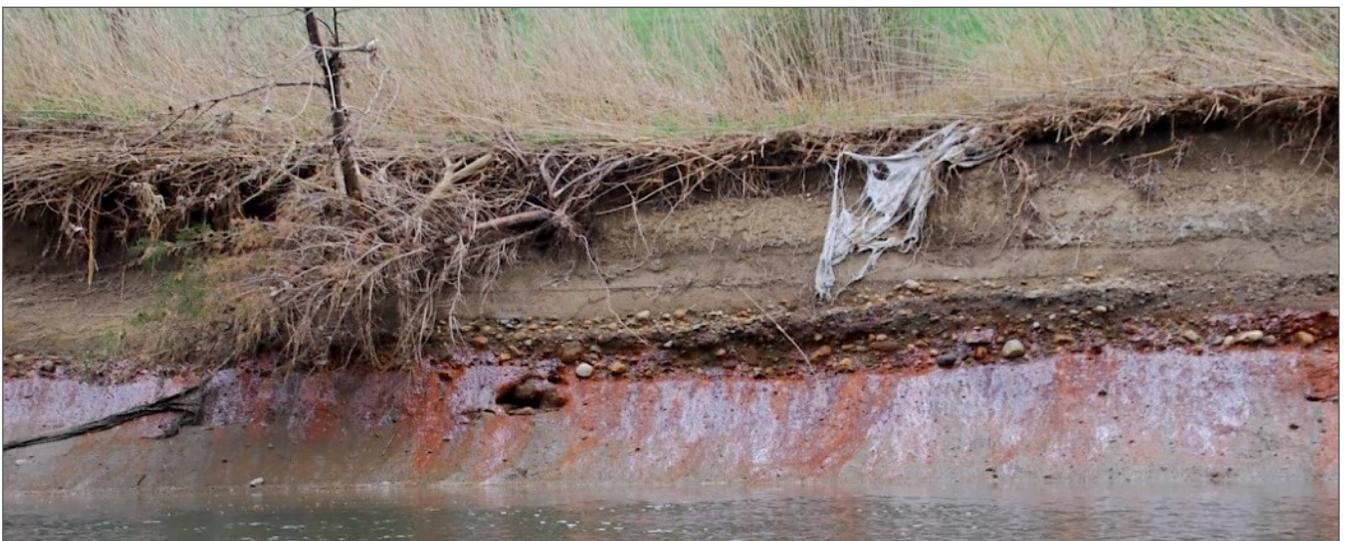
Eroding Riverbank downstream of the bend along the Old East Ash Pit. Eco-Justice Collaborative. May 2, 2018.

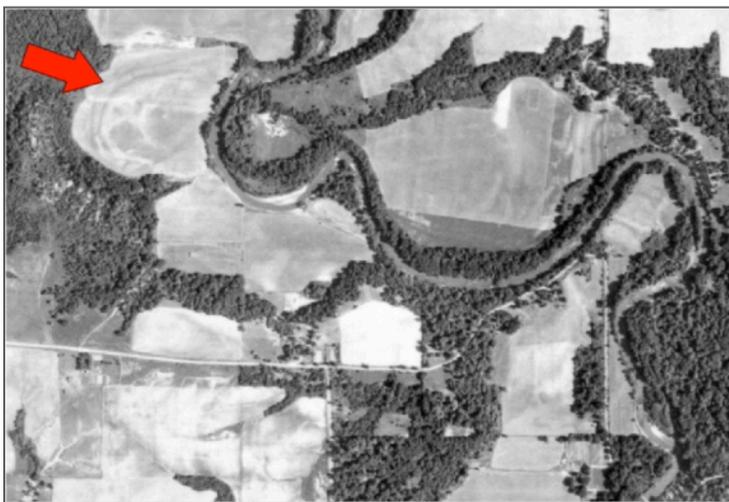
Meandering Rivers Move

The 1940 aerial photograph to the left shows the signature of an old meander bend at the western edge of the Middle Fork's floodplain (see the red arrow).

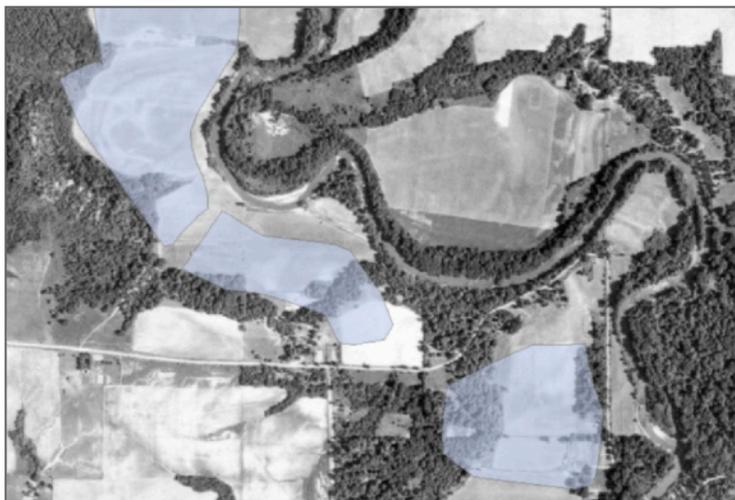
North Ash Pit On Top of Old Meander

Dynegy / Vistra's three coal ash pits are shown superimposed on the 1940's aerial.

The North Ash Pit, built in the Middle Fork's floodplain, now sits in a location where the river channel once was. This graphic depicts how much the river moved over time, and shows the dynamic nature of the meandering Middle Fork.

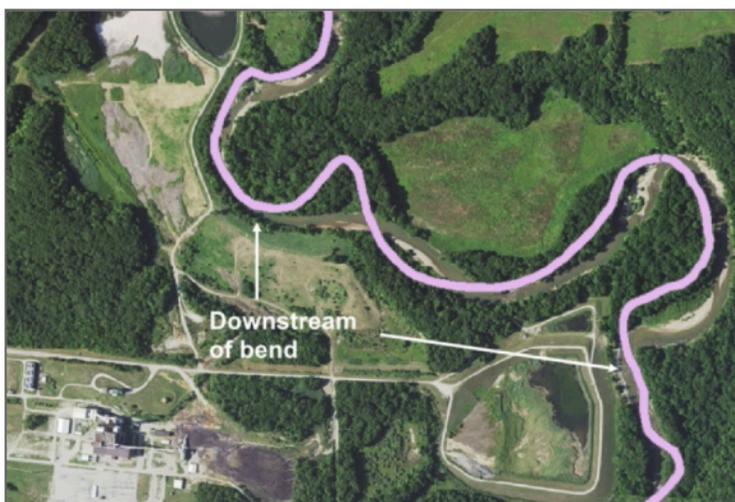
Erosion - Downstream of a Bend

This 2017 aerial shows the river channel as it exists today. The purple image shows the channel as it was in 1940. The Middle Fork has clearly moved, with erosion occurring most aggressively downstream of bends in the river. It has moved:

- 100 feet closer to the Old East Ash Pit, causing Dynegy / Vistra to evaluate the potential for failure and a coal ash spill.
- Close enough to the toe of the slope of the New East Ash Pit dam that emergency stabilization was installed in 2016.

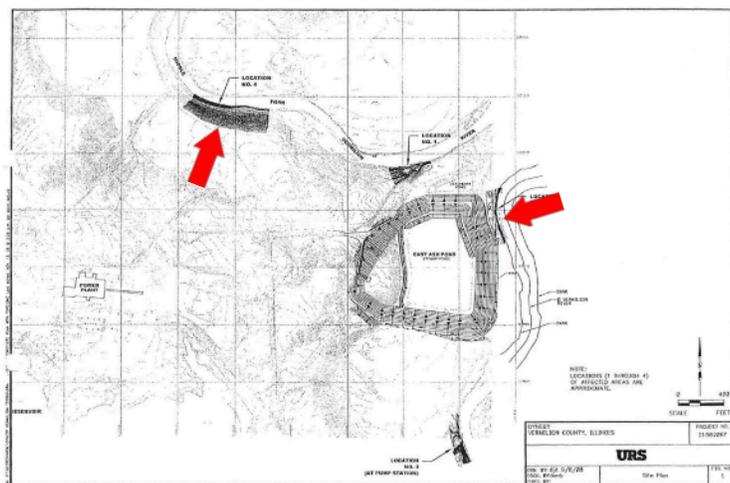
Dynegy's Application for Stabilization

This graphic was part of Dynegy's 2009 application to the U.S. Army Corps of Engineers and the National Park Service to repair 740 linear feet of gabions along riverbanks next to the Old East Ash Pit, and install 485 linear feet of new gabions along banks adjacent to the New East Ash Pit.

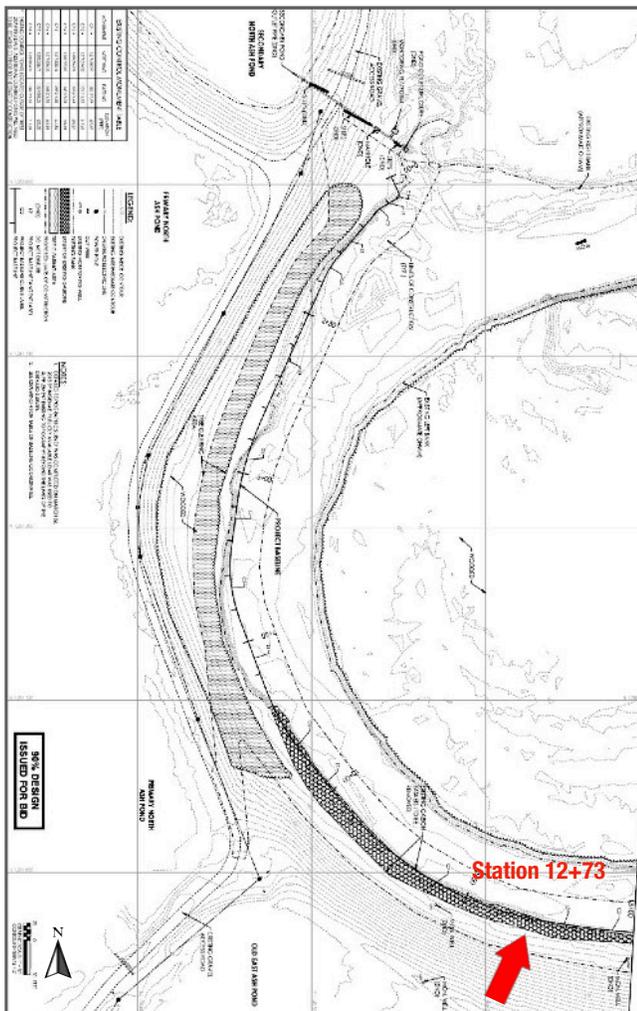
Construction Drawings for Riverbank Stabilization, 2019.
Stantec Consulting Engineers, Inc.

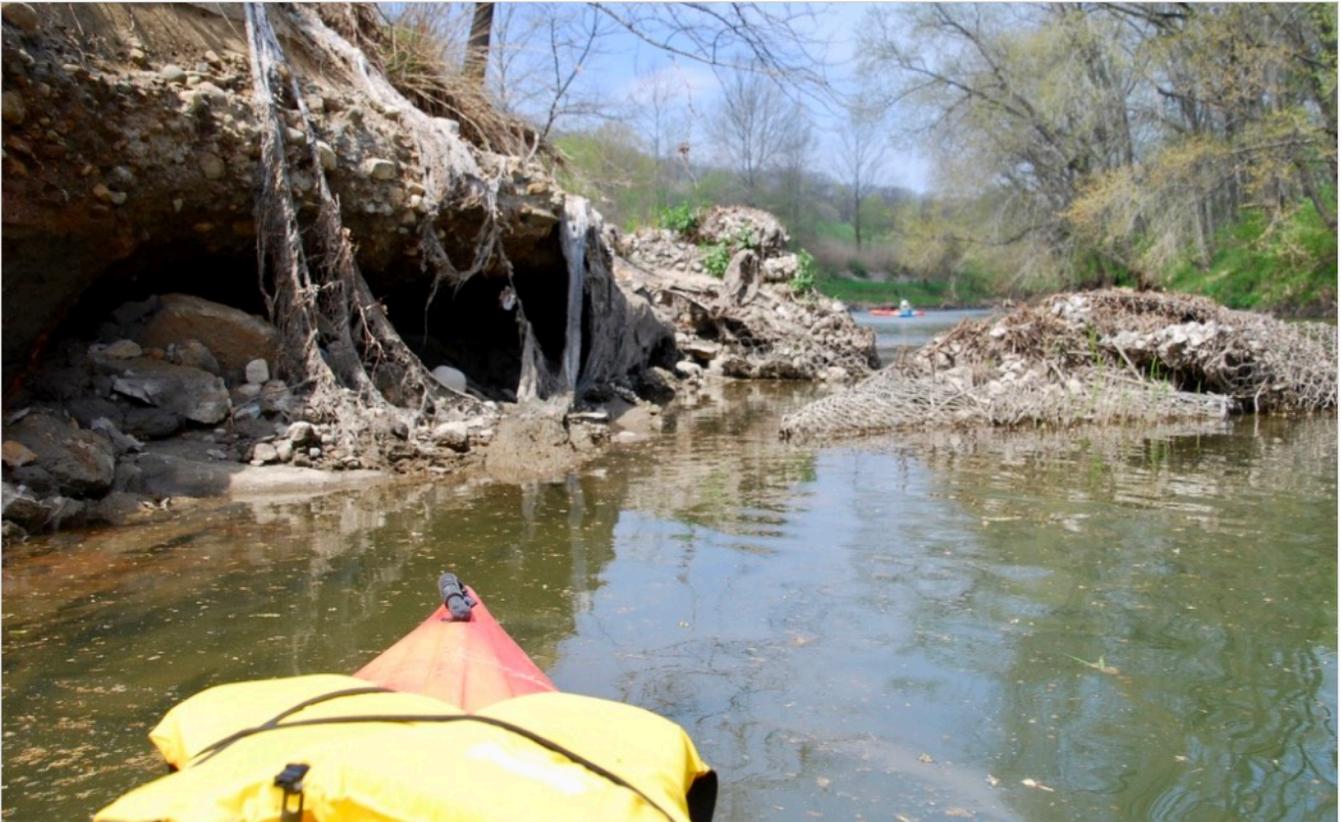
Erosion along Old East Ash Pit downstream of the bend in SECTION 2. Eco-Justice Collaborative. May 2 2018.

EJC is asking the IDNR to conduct its own investigation to determine the need for immediate, interim stabilization to prevent a coal ash spill. We are particularly concerned about riverbanks identified by Stantec in the area along the Old East Ash Pit that they have identified as Station 12+73 (see **Ash Pits Are Vulnerable to another Storm Event**, page 28). This area is downstream of a river bend, and is most vulnerable to erosion. It is important that this analysis be carried out quickly, since any future storm event could erode riverbanks to a point where dam destabilization occurs.

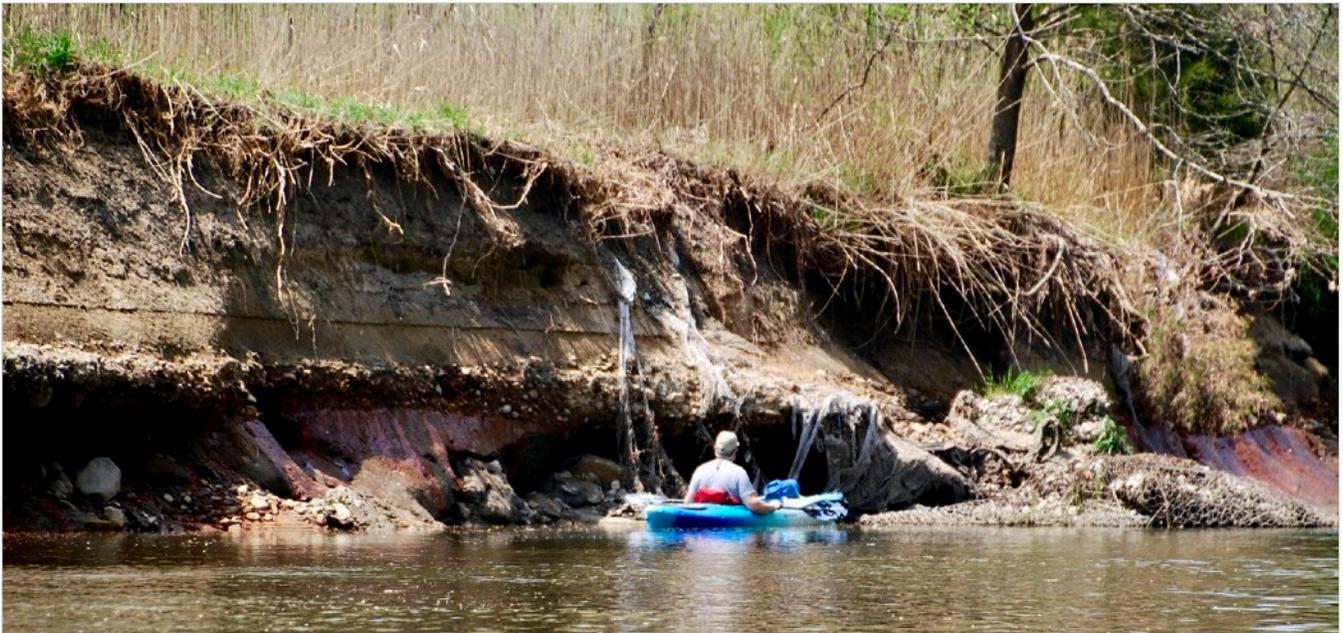
As photographs in this document show, there are several areas along the Old East Ash Pit where riverbanks have been undercut by the Middle Fork. Measurements taken from the top of bank to the toe of the adjacent dam, alone, will not accurately depict distance between the river and the Old East Ash Pit.

Erosion along the Old East Ash Pit downstream of the river bend in SECTION 2. EcoJustice Collaborative. May 2, 2018
